Geomorphic Assessment Survey for the Fenton River Project

Example Geomorphic Assessment

Geography 5310

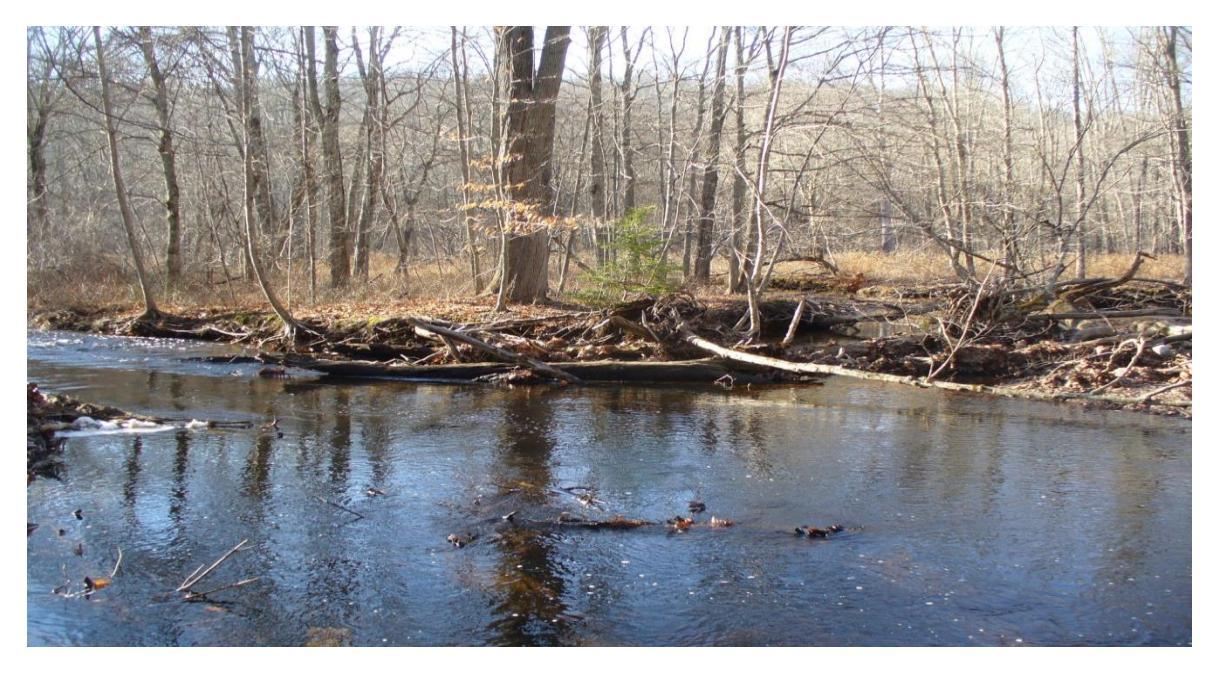
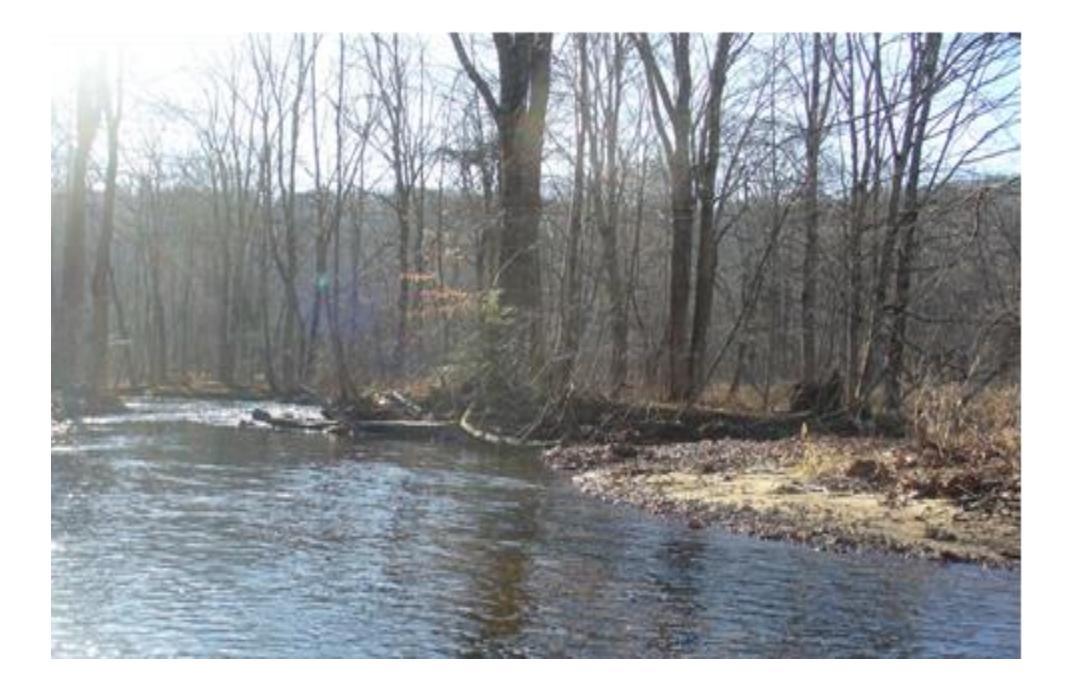
Looking west at island tip where large debris dam (on right) diverts flow into newer channel (left) a small flow can be seen entering the previous main channel which continues on the west side of the island. Below: view of same debris dam from Cross Section 5. On the right is the relic point bar from when the area was a westward meander. On the left is the fenton continues into the newer primary flow path.

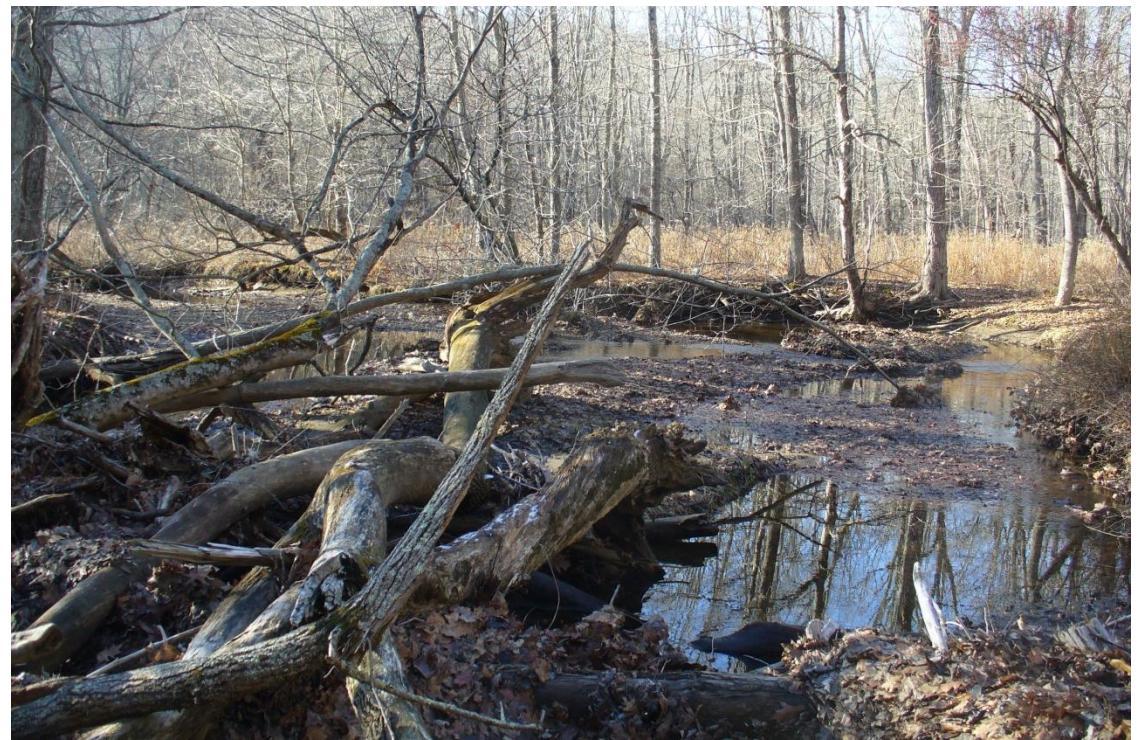
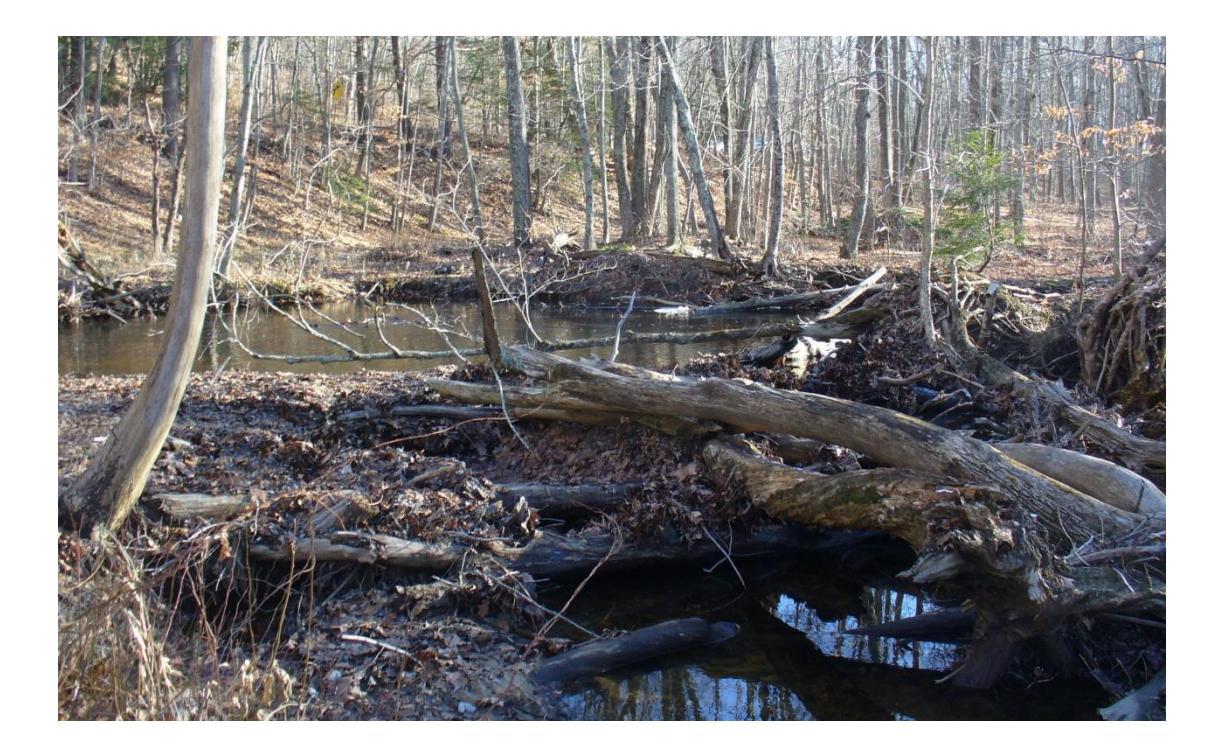
Above: Looking west, downstream from on top of the major debris dam toward the mostly abandoned previous channel

Below: Within the abandoned channel looking toward the east at the downstream side of the debris dam

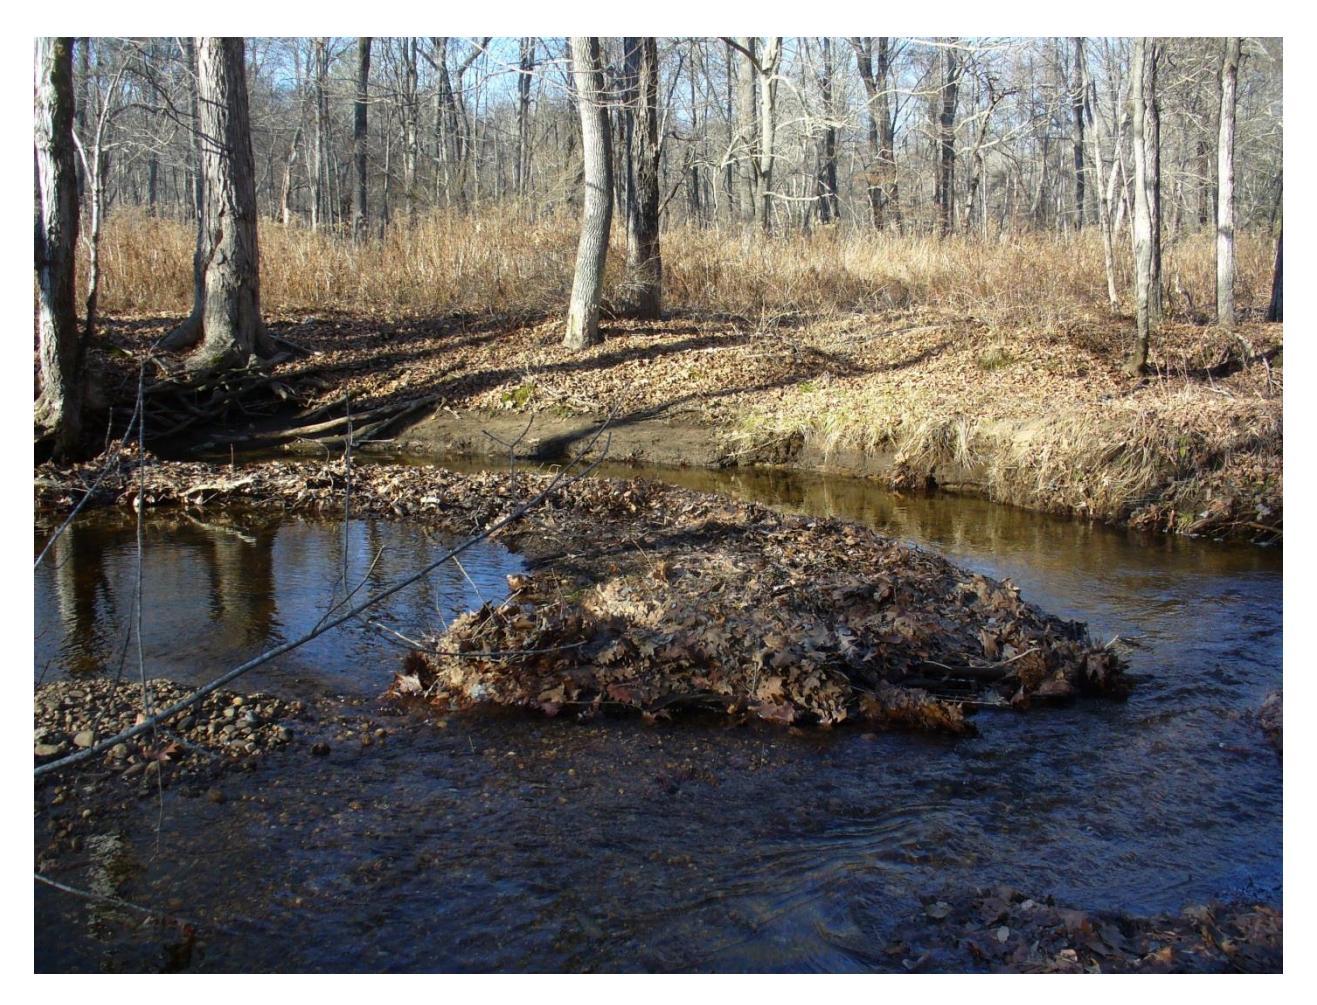
Downstream of debris dam in old channel closer view of flow bifurcation as it flows from a gravel bar into a crescent soil and leaf bar which showed the presence of root structures. This feature could possibly have been a historic bank before the flow was diverted upstream. Most of what little flow passes the debris dam passes along the far side of the curve, eroding into the exposed soils there. This area is bisected by cross section 10 which crosses the leaf covered bar just left of the center of field.

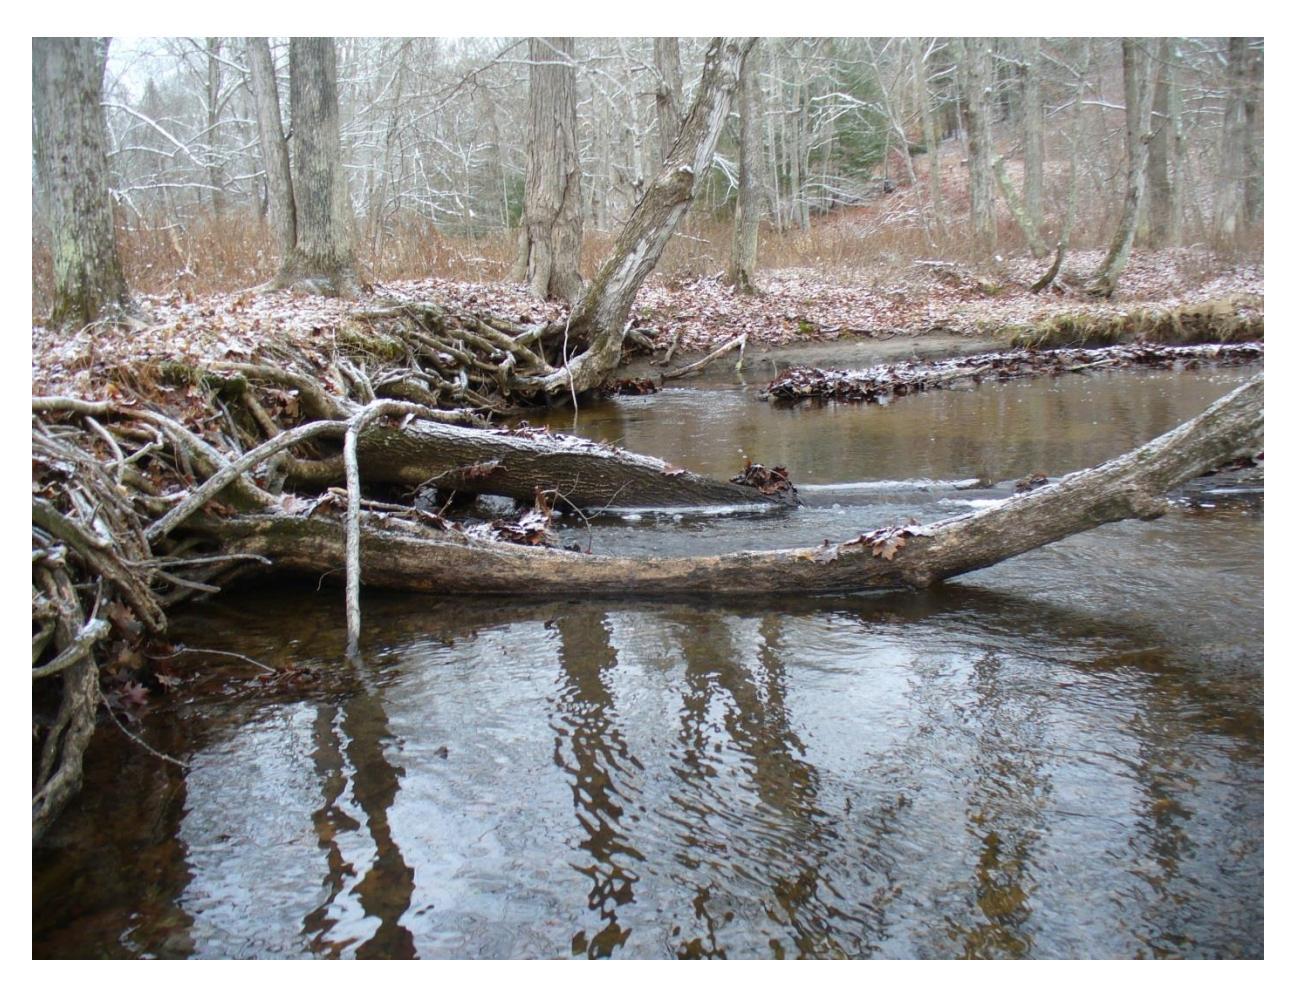
Trees slumping into channel with the north bank/west bank of Cross Section 10 visible. The trees are slumping from an inactive cut bank on the West bank

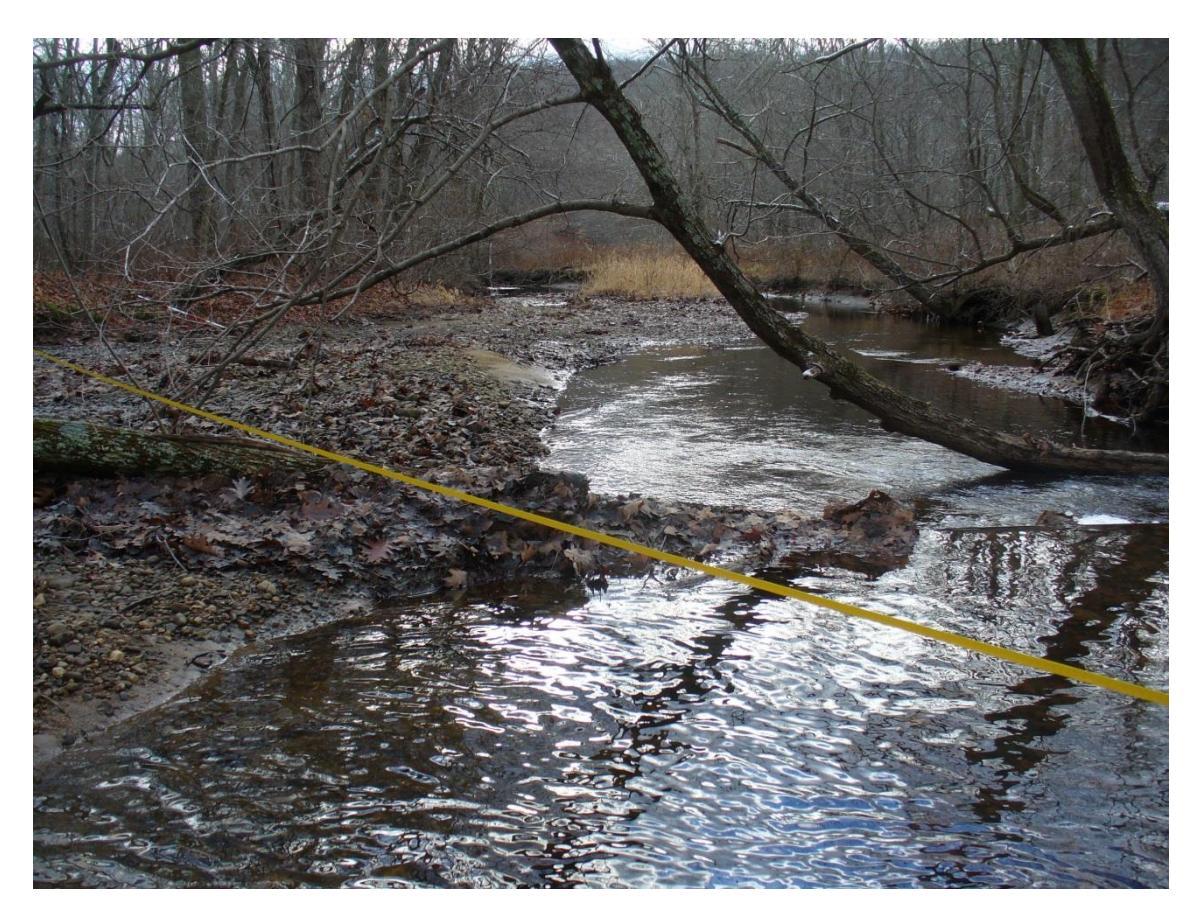
View downstream from Cross Section 10. On left is gravel and sand mid channel bar blocking flow, possibly a point bar formed before the flow was diverted to a different channel. The right bank (west) shows inactive cut banks and trees slumping into the channel. In the far center field is a vegetated bar bounded shown in **APPENDIX__** (next page)

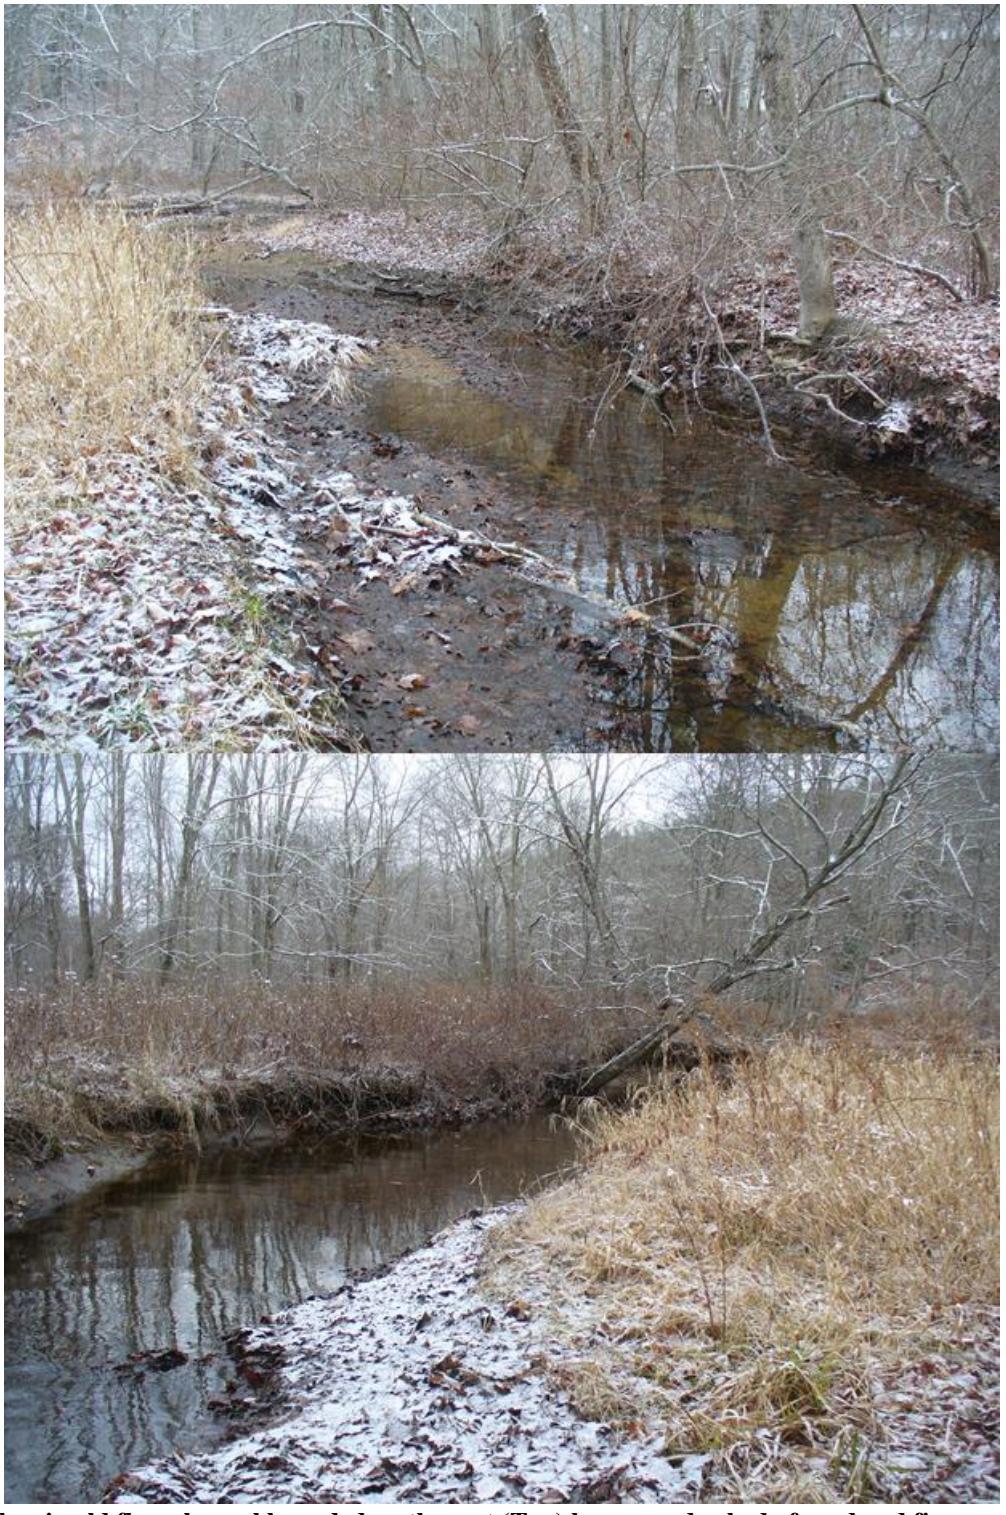
Vegetated bar in old flow channel bounded on the east (Top) by a now dry bed of sand and fine gravel and on west (Bottom) by the remnants flow within the channel with fine sand, silts. Both sides are now accumulating leaves and leaf derived muds.

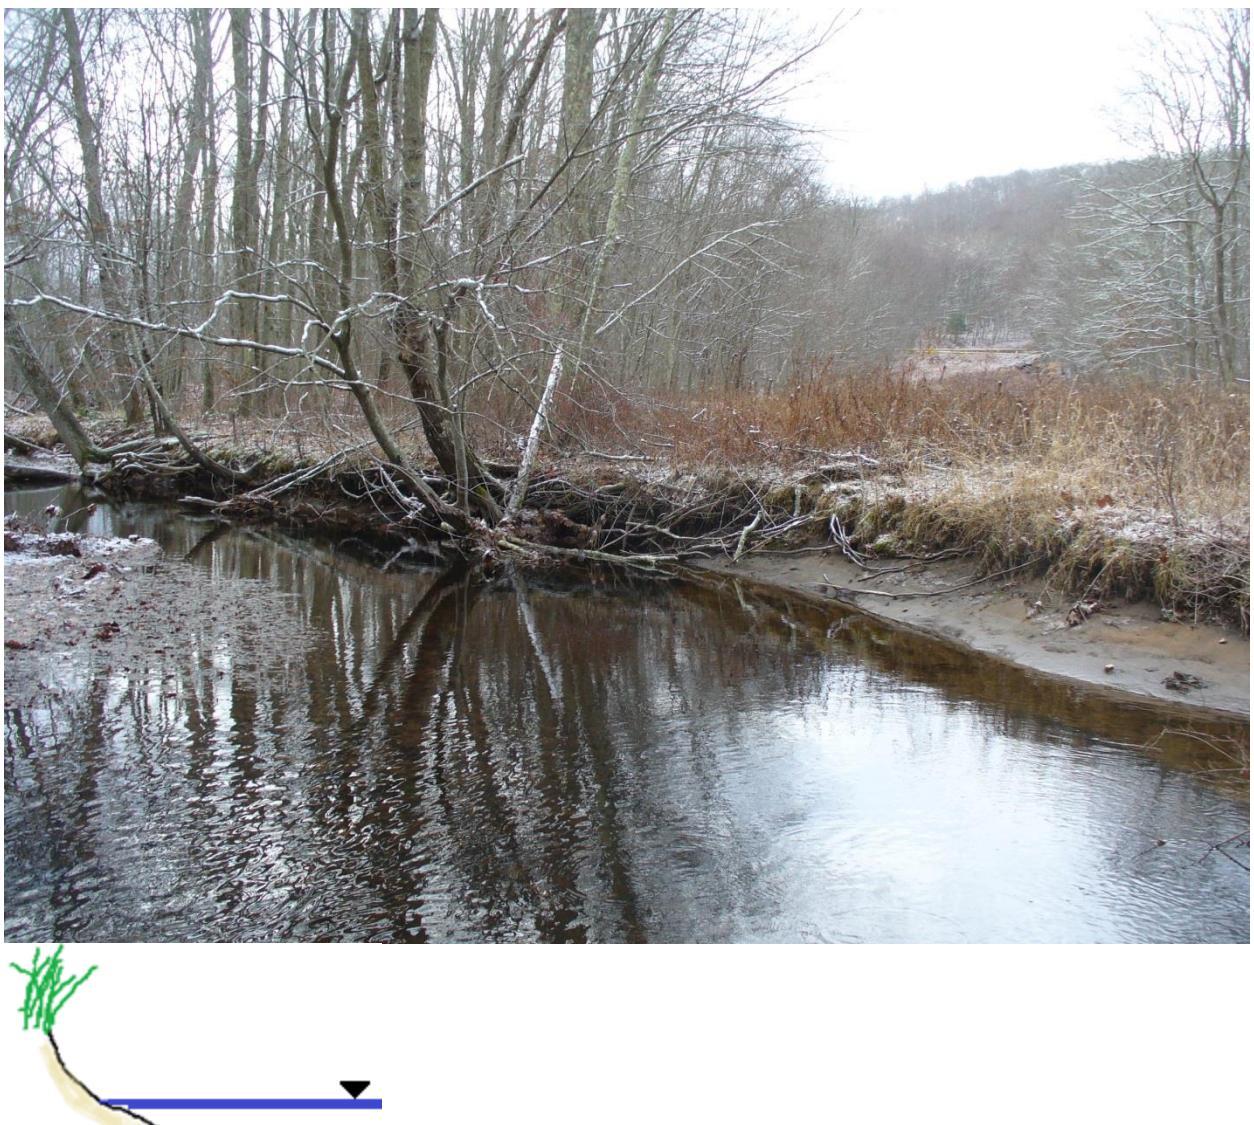
Looking toward the West bank in the relic channel. Note slumping trees from inactive cut banks and exposed banks. Above the exposed clays is looking down the tree cleared path of the gas line. The visible silt/clay is hard packed and continues underwater where there is a small undercut as described by the schematic.

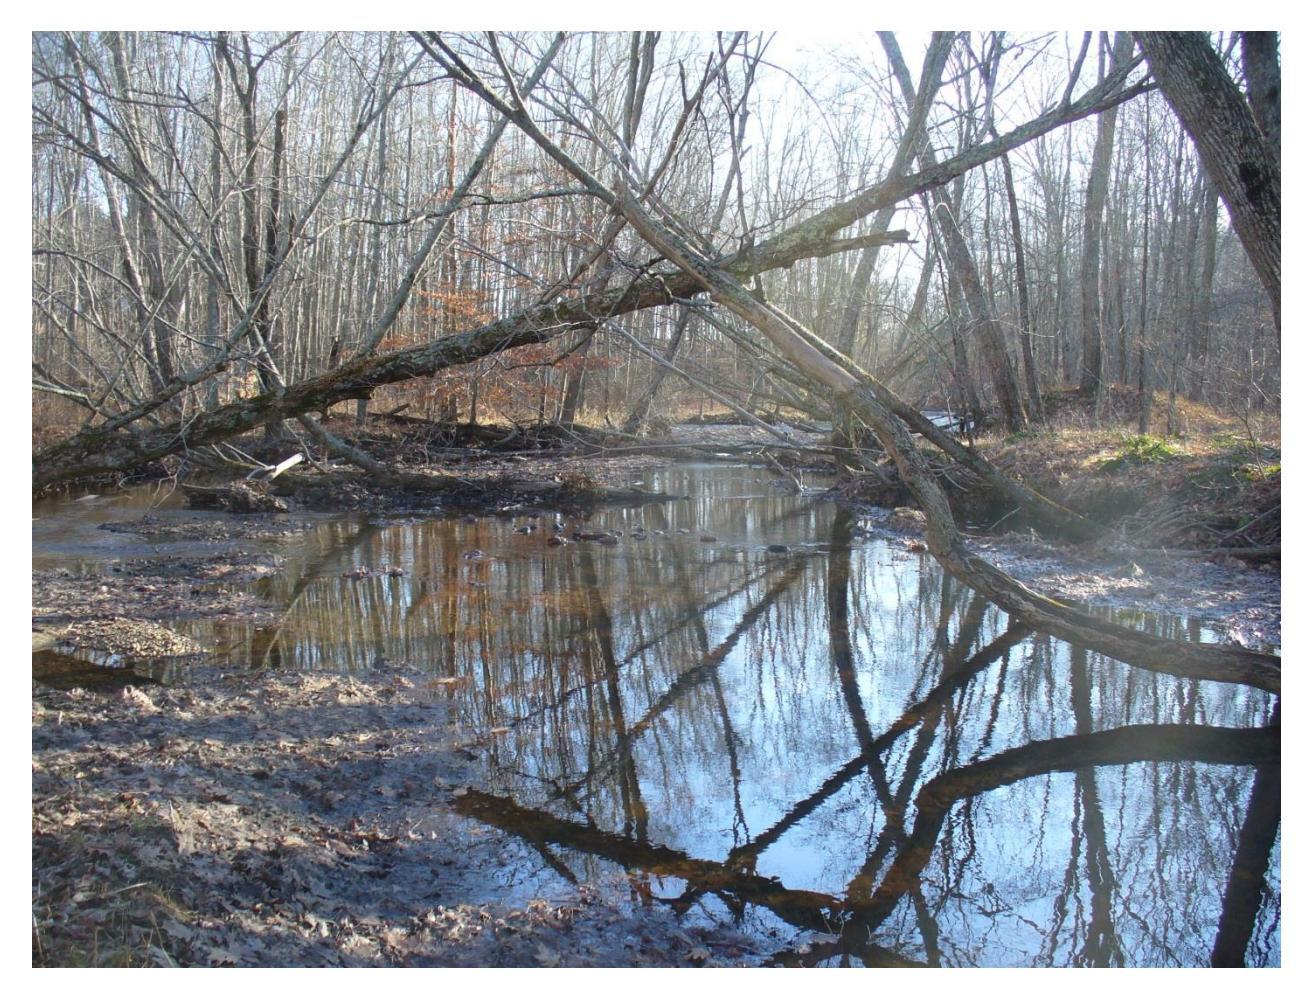
In the old channel viewing downstream from cross section 8. Reduced flow here has left many slumping trees which would otherwise have been cleared by floodwaters. The density of woody debris has created complicated flow paths around sand and gravel bars with thick accumulations of leaves in slower areas.

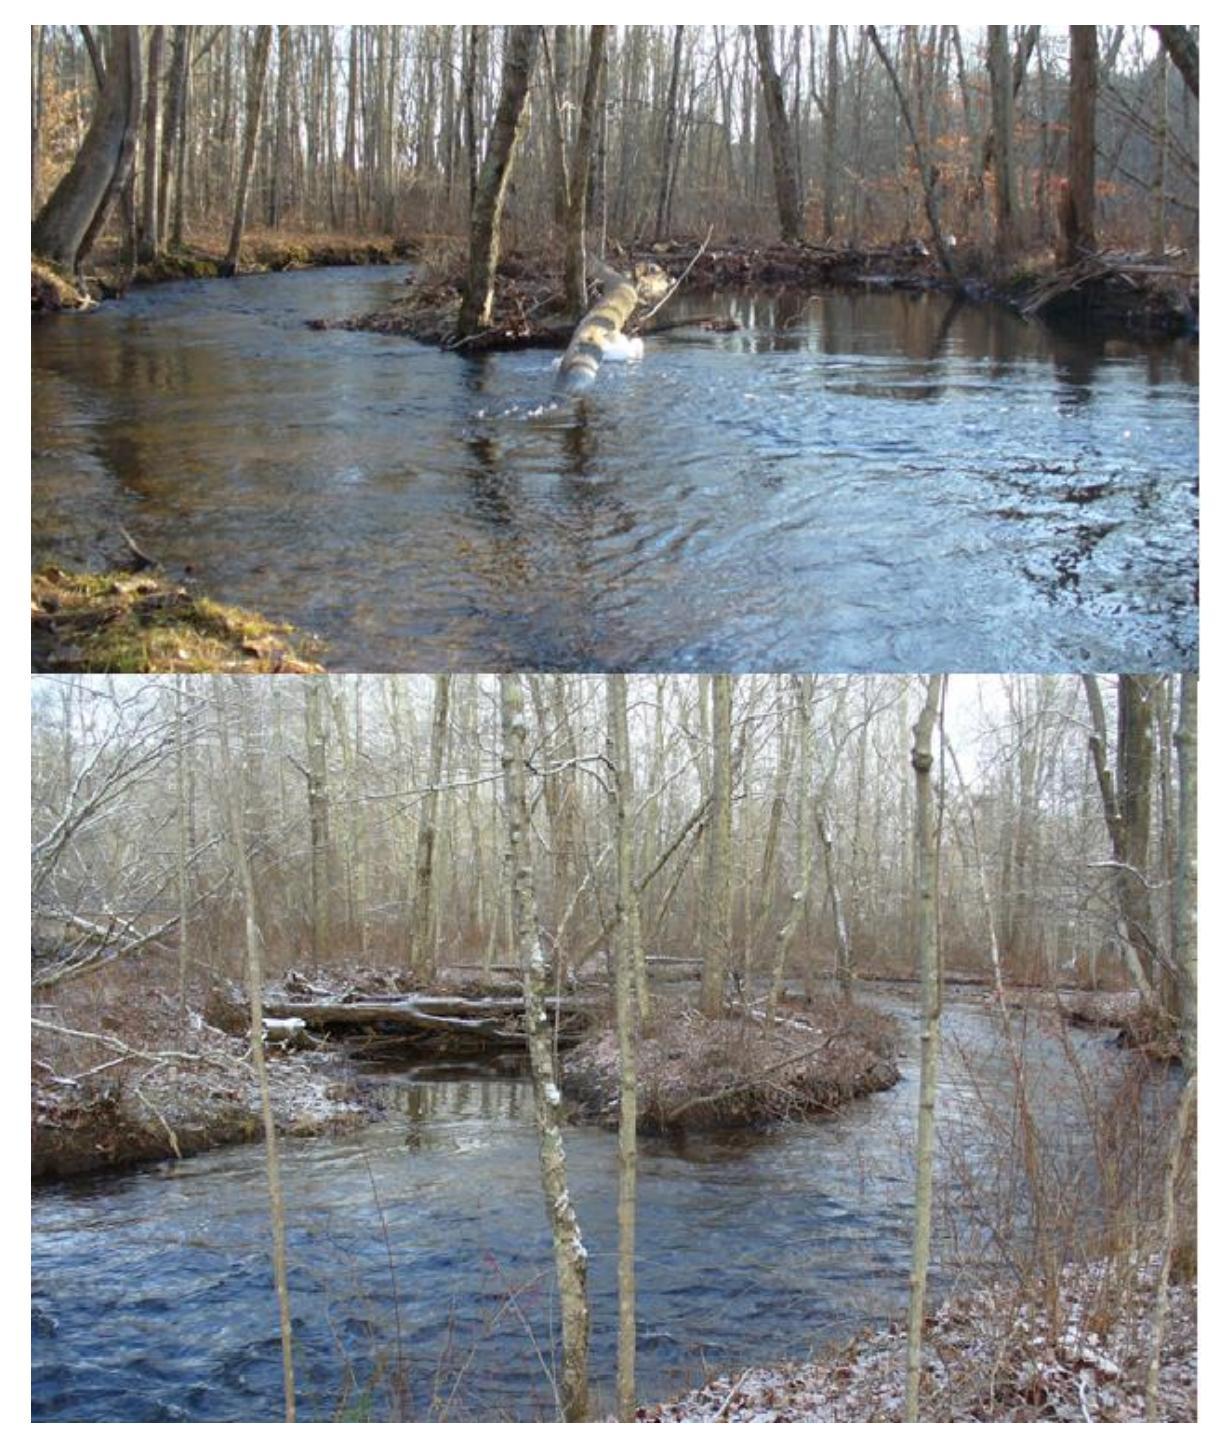
Top: looking downstream toward island with debris interrupted flow (right) and main flow (left), region covered by cross section 4.

Bottom: looking upstream at the same island with the debris dam blocking the flow visible on left and the main flow curving around the island on the right (east), downstream tip of island and both flow structures encompassed in cross section 3.

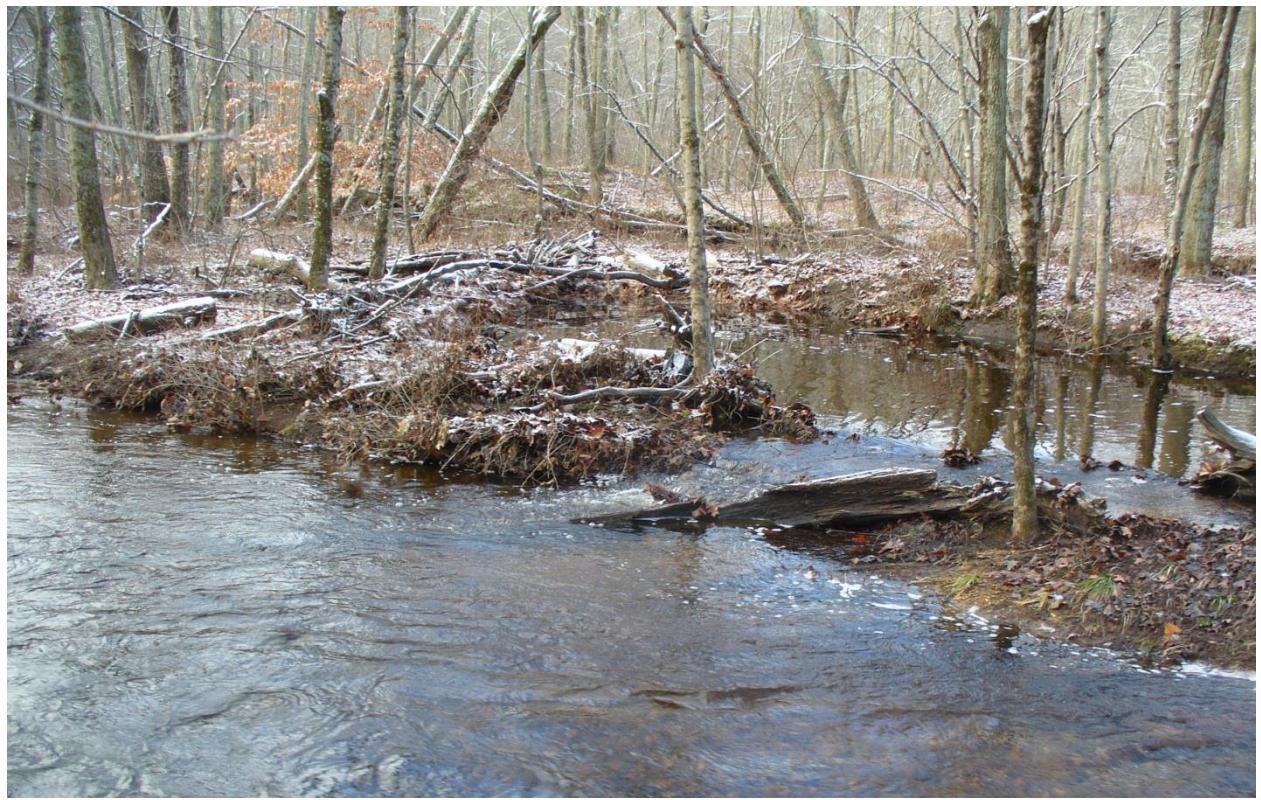
Looking from the east bank at the bifurcated flow, far is the debris dam blocked channel and close is the main channel. Overflow is seen crossing the island between the two channels with flattened grass on the right of the overflow showing evidence of even greater overflows from the blocked channel into the main channel.

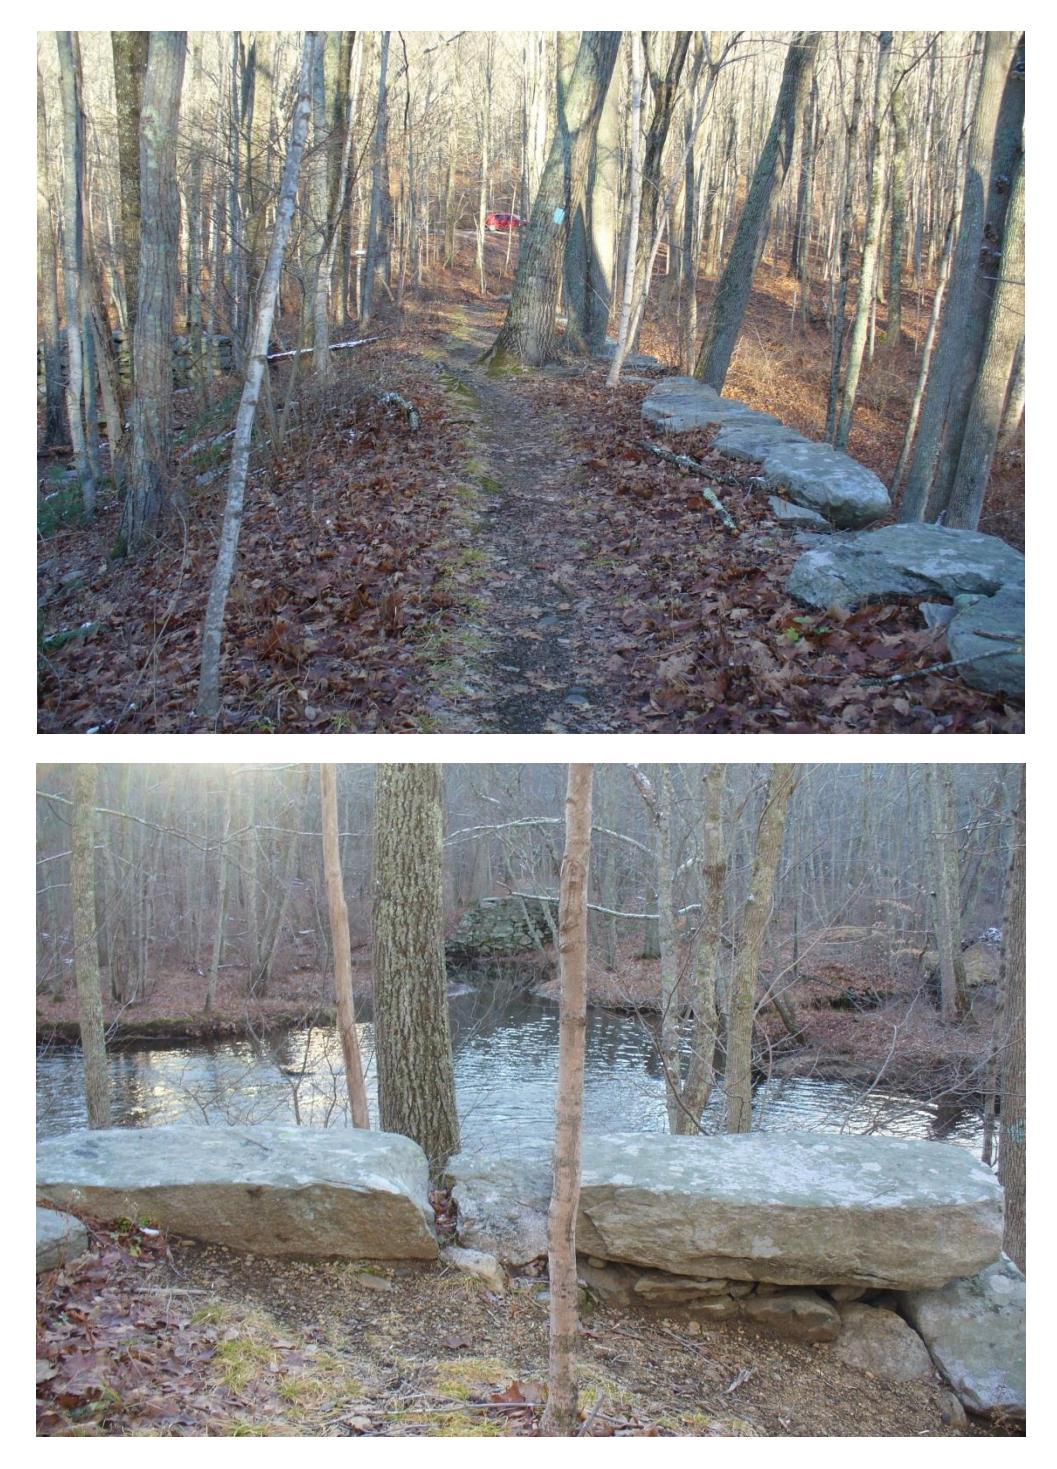
Views from top of Old Mill Pond dam. Top: looking back toward Chaffeeville road vertical drop to the right side of the path, the earthen slope signifying the submerged side of the dam on left side of the path. Bottom: Looking west across the Fenton from the end of the dam toward the continuation of the dam on the far West bank.

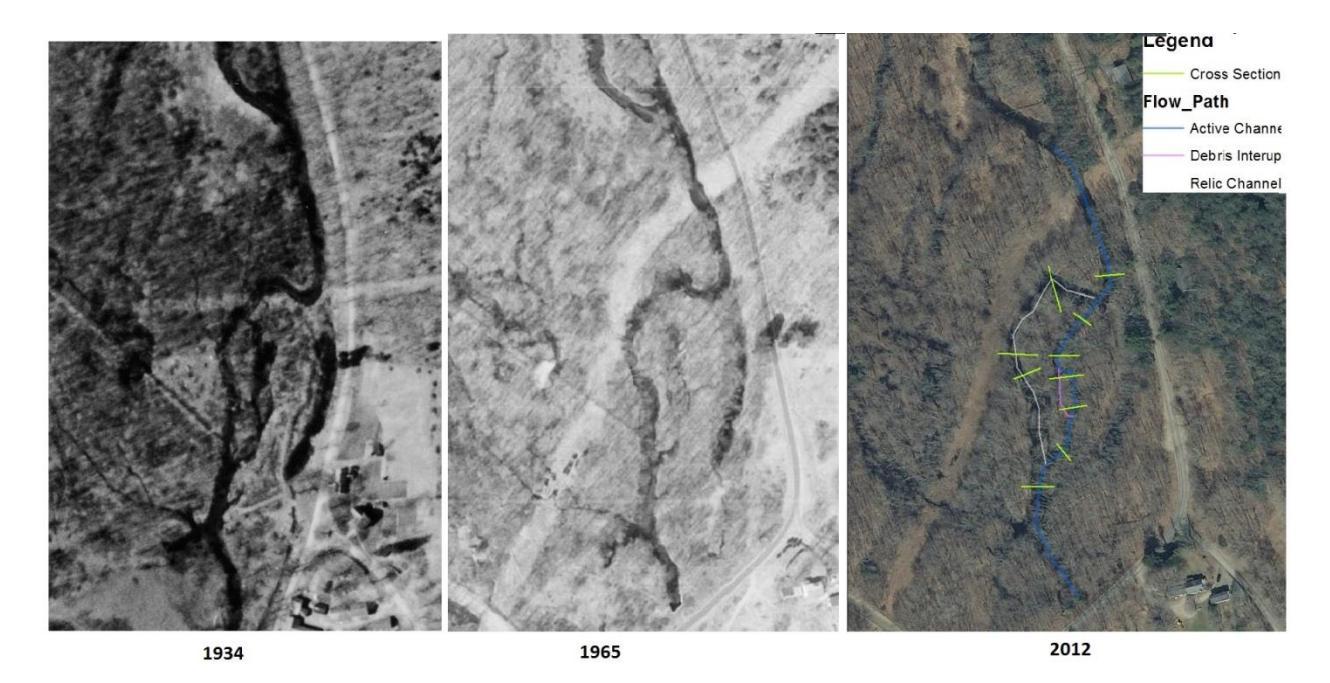
Aerial photos of the studied reach over time, the water visible as darker regions on the image. The gas pipeline path cleared of trees was completed in 1953. The current main pathway shown in blue on the 2012 photo is clearly different from the past flows shown by the older photos. Water filling the historic raceway path can be seen ponded to the east (right) close to the road in all the photos. Also clear is the apparent stability of the floodplain channel entering the Fenton from the west in the lower extent of the photo, just upstream of the dam, present in each photo.
