Geomorphic Assessment Survey for the Fenton River Project

Example Geomorphic Assessment

Geography 5310

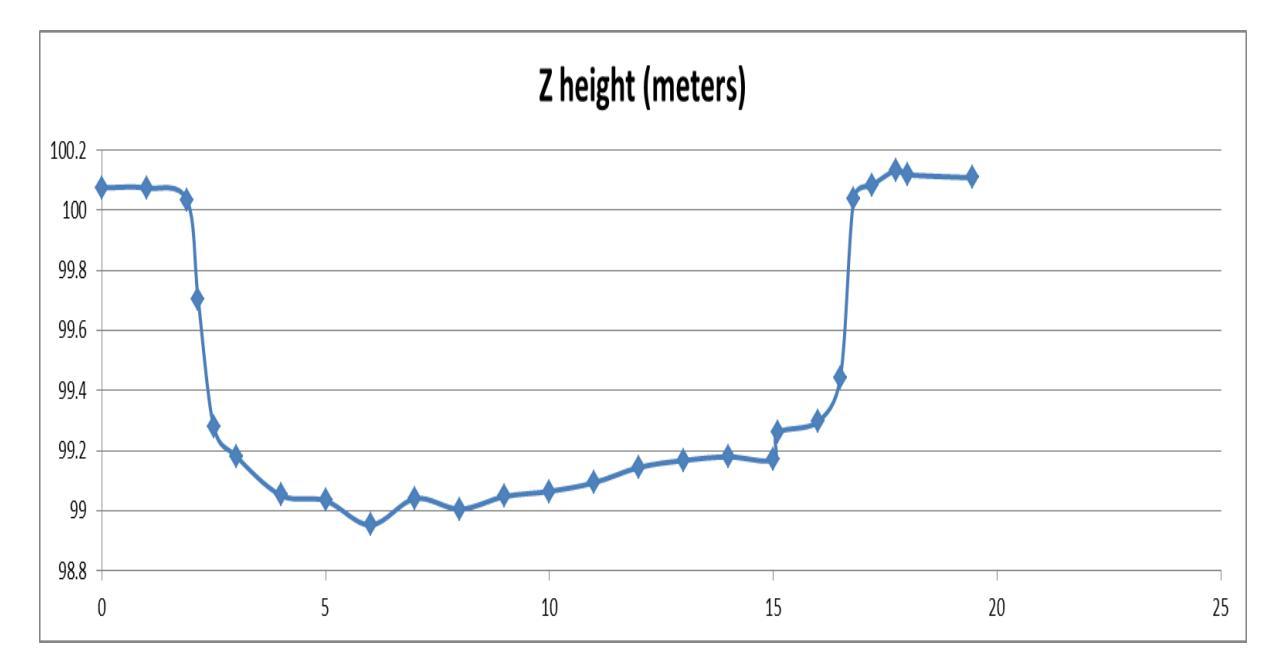
Fig 3 Cross section 1elevation gradient

Cross section 1 was surveyed the most downstream of all sites. The profile of the stream was measured from a distance of 19.45 meters from each flood plain above the banks (**Fig 3**). The channel was a chosen as a base profile for the geomorphic assessment. The general geomorphology of the stream is characterized as straight. The substrate of the stream consisted of sand and cobble. On the flood plain on the farthest side of the bank consisted mainly of cobble and sand under the loamy bank. The depth profile of the stream had a varied relief. Along the banks, the highest elevation was 100.07m on the near side and highest was 100.135m on the traversing side. At a distance of 15.1m is where the water level was and its elevation was 99.26m. The deepest point in the channel profile 98.953m.

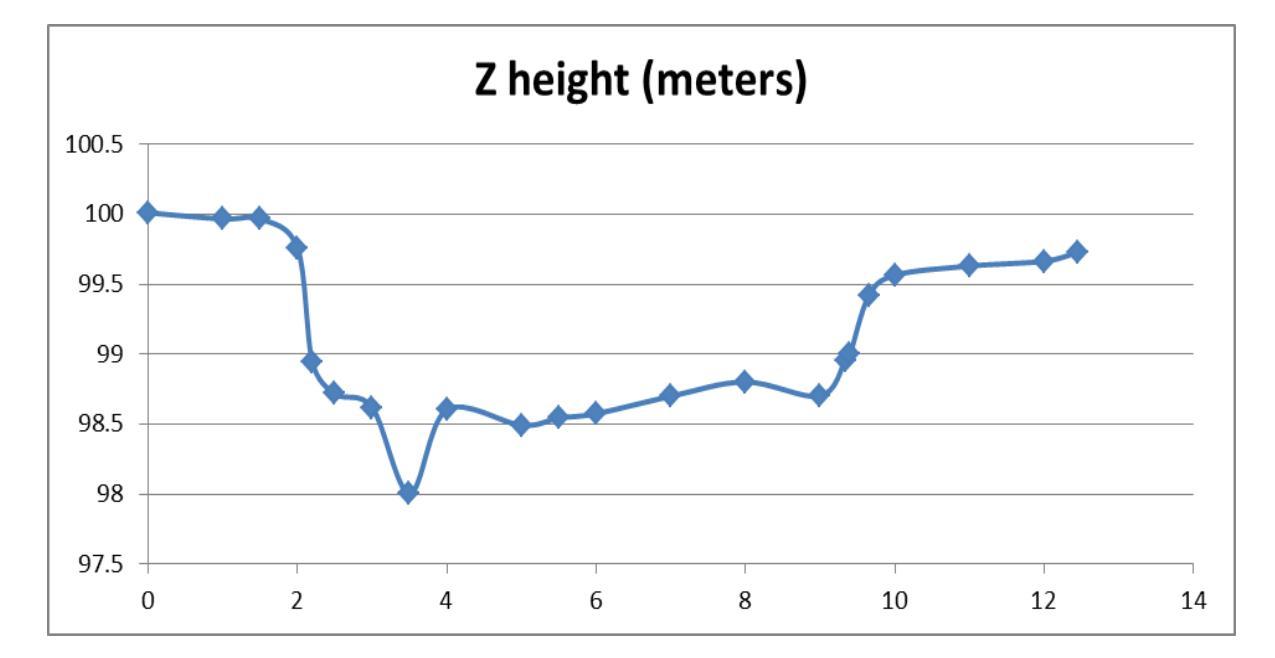
Figure 5 Cross section 2 elevation gradient

Cross section 2 was surveyed above the first site and downstream of the other survey sites. The location of the site was 41.79536 North and 72.20973 West. The entire channel profile of the stream was measured at distance form 12.45m from both sides of the flood plains above the banks (**Fig 5**). This channel was surveyed due to its presence erosion on the bank. The cut bank was apparent and subjected to high flow activity and probable backflow from the stream. The substrate of the stream varied along the profile. On the near side of the channel was

undercutting with a minor slump. Along the channel of the cross section, the sediments were clay, gravel, cobble, and eventually gravel and sand mixture. This change in substrate occurs within a few meters. On the traverse side of the channel, there is an island between the new and old channel. The island is composed of different soil types. The depth profile of stream varied between the floodplains on each of the sides. Beginning on the nearest side the highest elevation was 100.01m and highest at 99.728 on the traverse side. The water levels reached from 2.2m to 9.4 meters. The deepest point the channel profile was 98.005m. This deep point was characteristic of the entire relief of the profile. Also noted upstream of the channel was large cobbles and small boulders greater than 30cm.

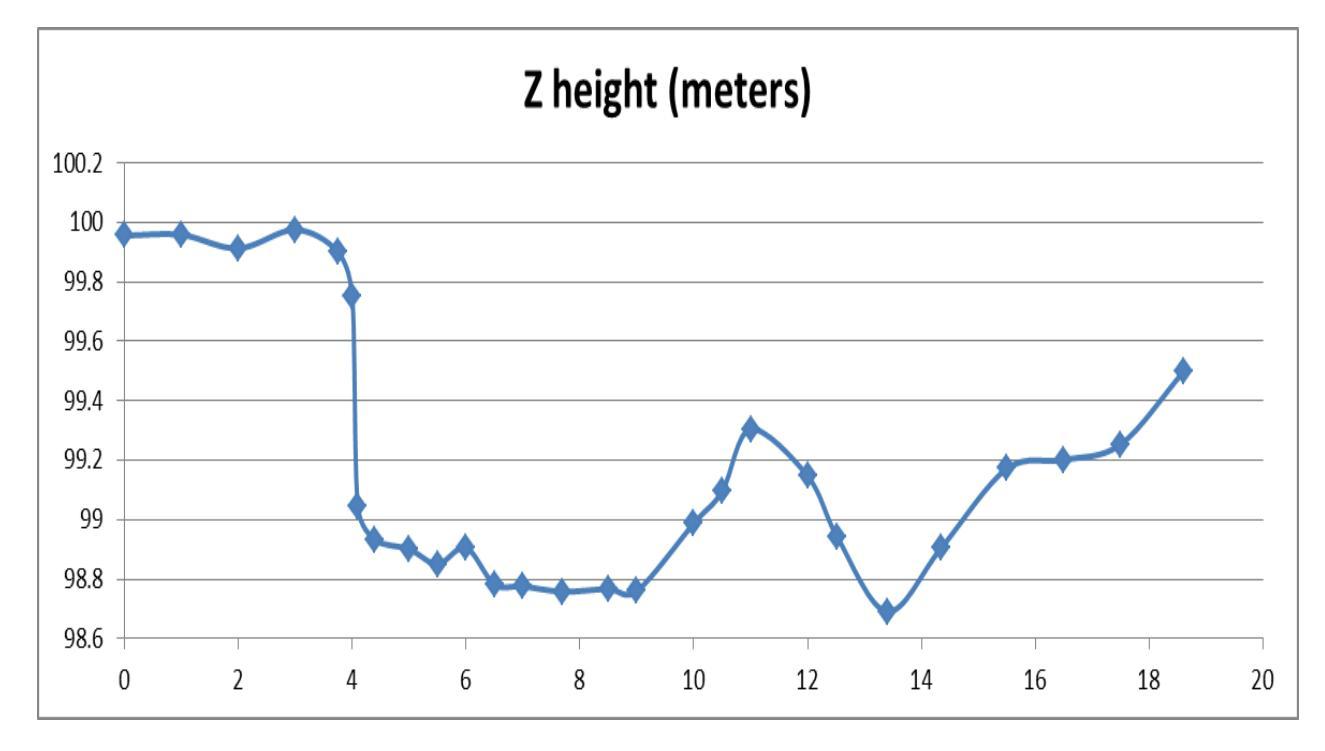
Figure 7 Cross section 3 elevation gradient

Cross section 3 was surveyed downstream above sites 1 and 2. The location was 41.79559 N and 72.2053 W. The channel was surveyed for geomorphic change due to its high erosion activity along the banks. This channel was bisected with a new stream flow path created, due to the old channel being impeded by a notable log jam. Upstream of the survey was a major debris dam diversion that caused the flow path change downstream. The survey was conducted at the length of 18.6m from the flood plains of each side of the stream (**Fig 7**). On the nearest

side of the channel there was a noticeable cut bank which consisted of loam and clay. The substrate in the stream varied with from the nearest banks being a mixture of clay, cobbles, and sand. In the middle of the stream, the substrate was a mixture of cobble and gravel varying in different sizes. The far side of the channel was the bank island body. There was also secondary overflow on this island. The depth profile of the channel varied. Along the nearest flood plain the highest elevation was 99.976m and on the far side of the channel the elevation was 99.498m. The deepest points in the stream were 98.783m in the main channel and in the minor channel before the island body was 98.961m.

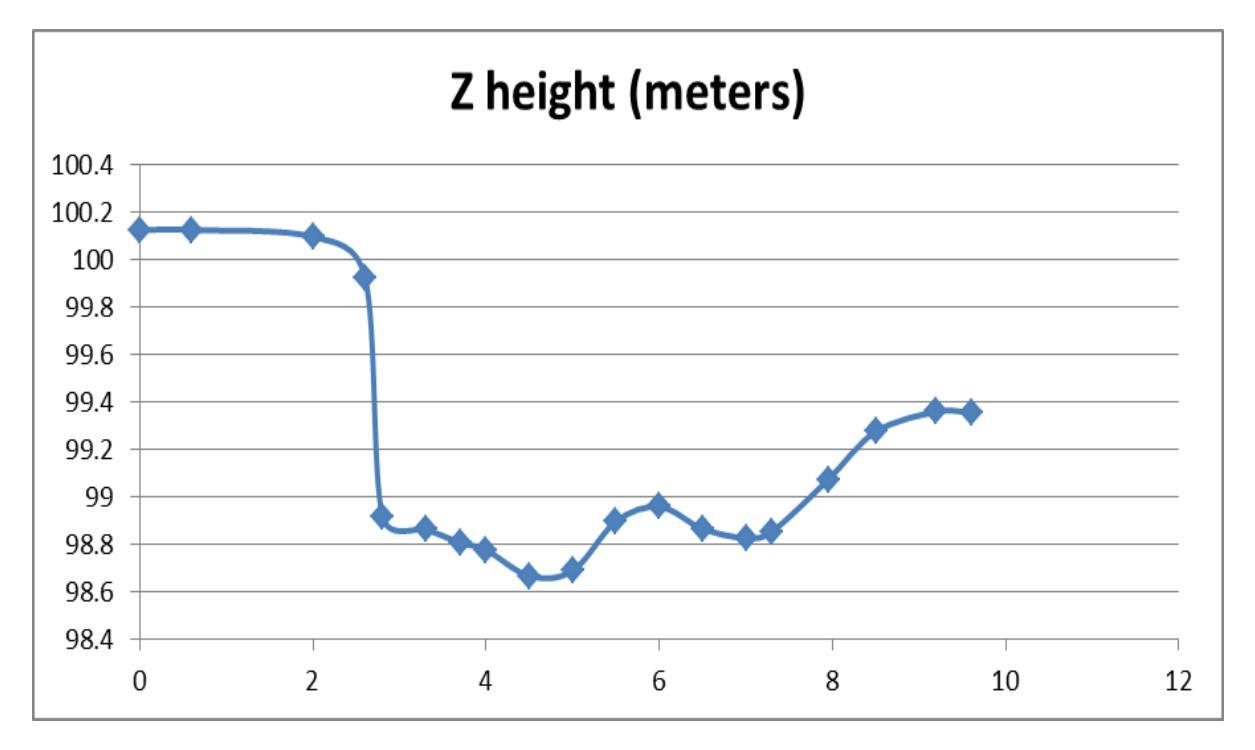
Figure 9 Cross section 4 elevation gradient

Cross section 4 was surveyed downstream and above sites 1, 2, and 3. The location of the site survey was 41.79579 North and 72.20931 West. This channel exhibited a cut bank with high erosion activity. The channel was downstream of the upstream flow diversion. The geomorphic survey was conducted at a distance of 9.6m from each side of the flood plains (**Fig 9**). The water level was from a distance 2.8m in to 7.3m. The substrate of the channel varied from each banks. On the nearest bank, there was an overhang with finer till, sand, and gravel sediments. In the middle of the stream towards the farther side the bed sediment was mostly gravel sediments. The depth profile exhibited a great slope from the nearest bank into water.

The highest elevation on the nearest flood plain was 100.126m and highest at 99.357m on the farthest side where the tip of an island body occurs. The deepest point the channel was 98.668m.

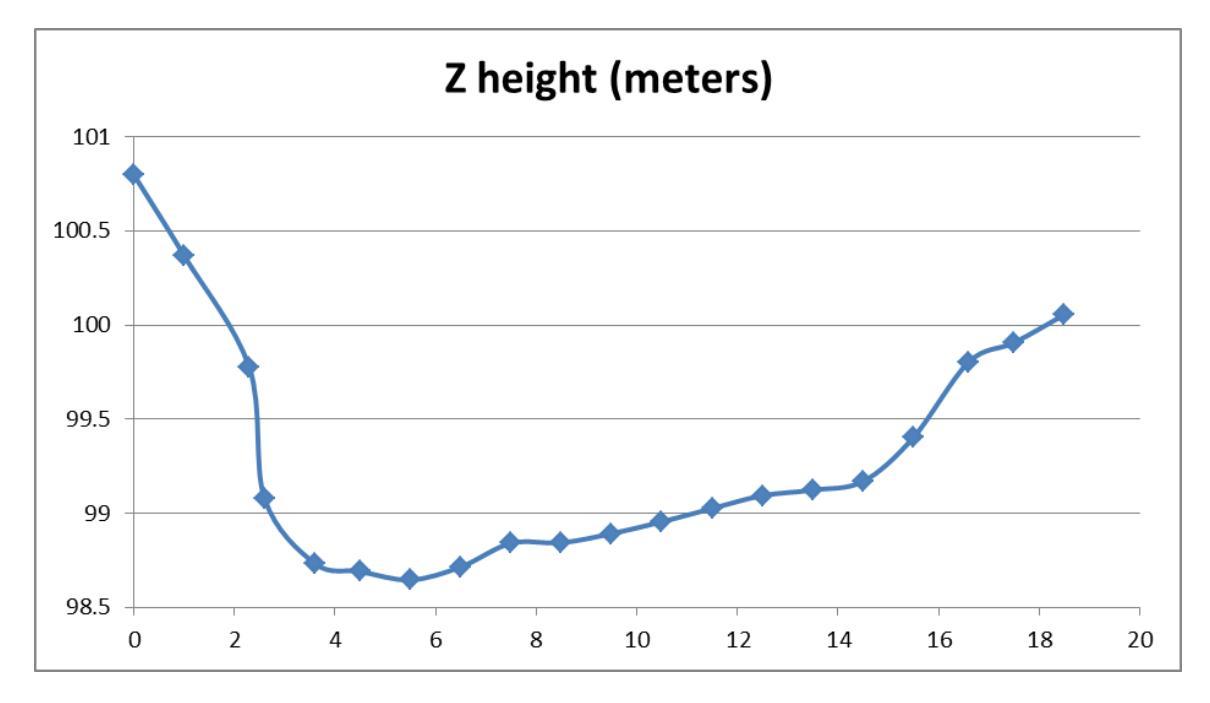
Figure 11 Cross section 5 elevation gradient

Cross section 5 was surveyed upstream above all other sites. The site was located upstream of the debris jam, where the old and new channel forms. The geomorphology of this cross section of the stream is characterized as a straight channel. The geomorphic survey was conducted at distance of 18.5m from each of the flood plains on the channels (**Fig 11**). The substrate of the stream varied. On the near side of the channel the water level begins at 2.6m with cobble rock mainly in the bed sediment. 6.5m into the stream, there was the presence of a large boulder. The far side of the channel was gravel sediments with an old point bar. The highest elevation on the near side was 100.8m and on the farther side of the channel the highest elevation was 100.055m. The deepest point in the stream was 98.646m.

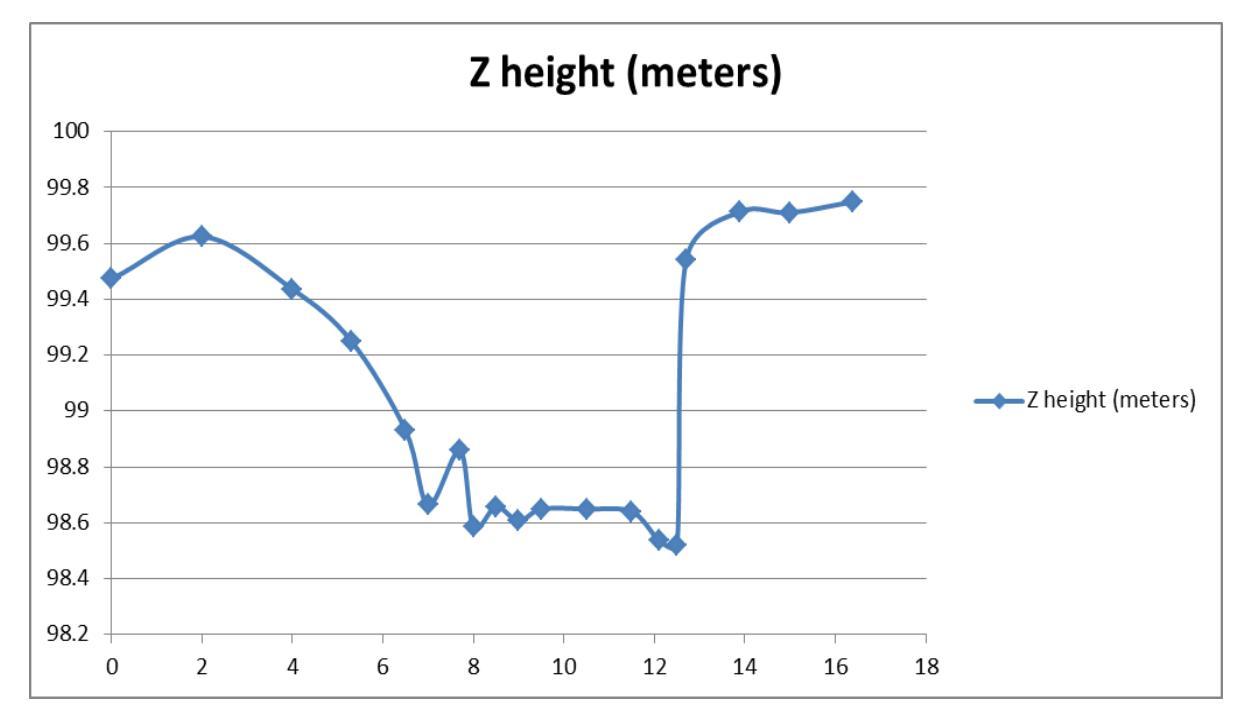
Figure 13 Cross section 6 elevation gradient

Cross section 6 was surveyed upstream just below site 5. The cross section was in the primary channel approximately 5m downstream of the debris dam where it redirects stream flow. The survey of the cross section was 16.39m for each flood plain of the channels (**Fig 13**). The substrate varied in sediments. On the near side of the floodplain there was noticeable flood debris. At 6.5m the water level begins and is mainly composed of cobbles. At 8m in, there were large rocks and cobbles greater than 30cm. On the far side of the channel before the flood plain the substrate is mixed gravel with a small cobble bar. There is a cut bank that overhangs on submerged clay and silt before the island body of the flood plain. The cut bank overhangs approximately 56cm over the stream. The highest elevation for the near side of the flood plain

was 99.624m and highest on the far side, on the island was 99.749m. The deepest point of the stream was 98.538m.

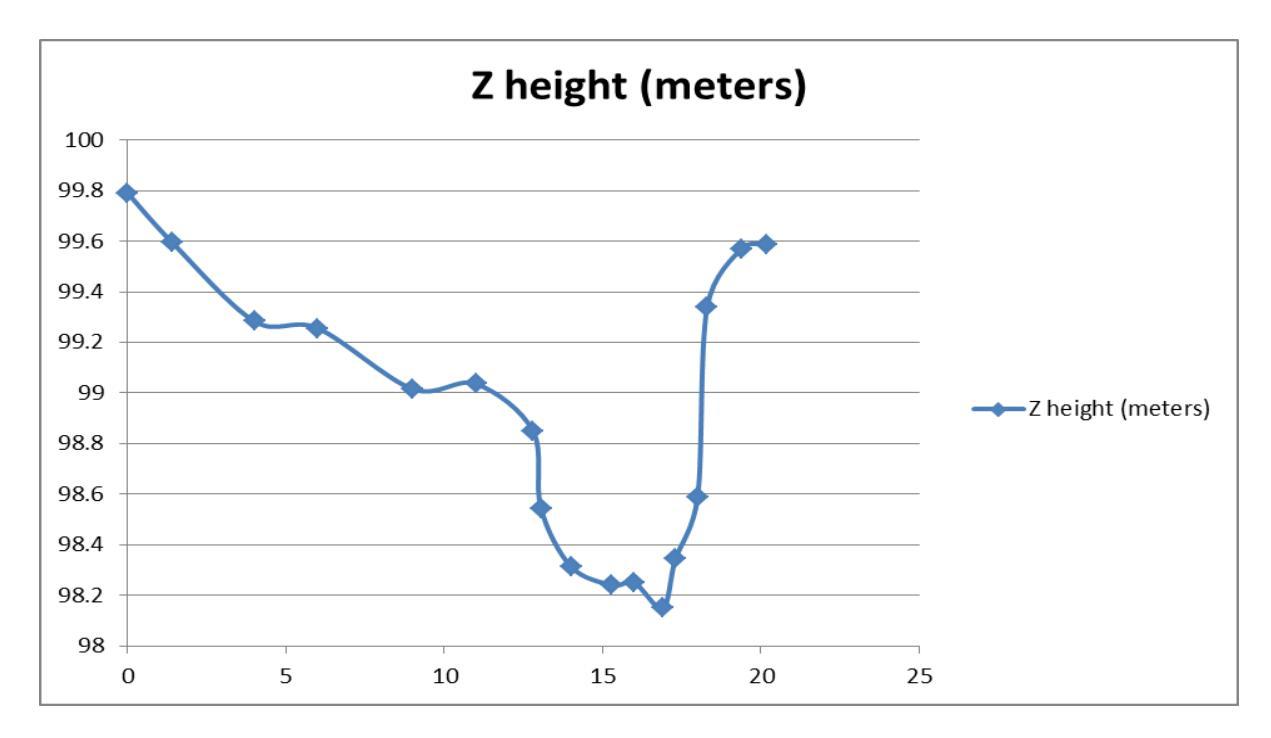
Figure 15 Cross section 7 elevation gradient

Cross section 7 was surveyed upstream and below sites 6 and 5. The channel could be characterized as a meander bend that includes a "grassy" point bar like feature. The geomorphic survey was conducted at a distance of 20.2m from the flood plains of the channel (**Fig 15**). The substrate sediments varied from one side of the channel to the other. On the near side of the channel there was a point bar predominately of soil. At 12.8m, where the water level begins soil is present, but transitions into sand and gravel. On the far side of the channel, the substrate is compacted silt and clay. The far side of the channel has a cut bank that reaches the island flood plain. The highest elevation on the near side is 99.79m on the flood plain and highest at 99.587m on the flood plain of the island. The deepest point of the stream was 98.15m.

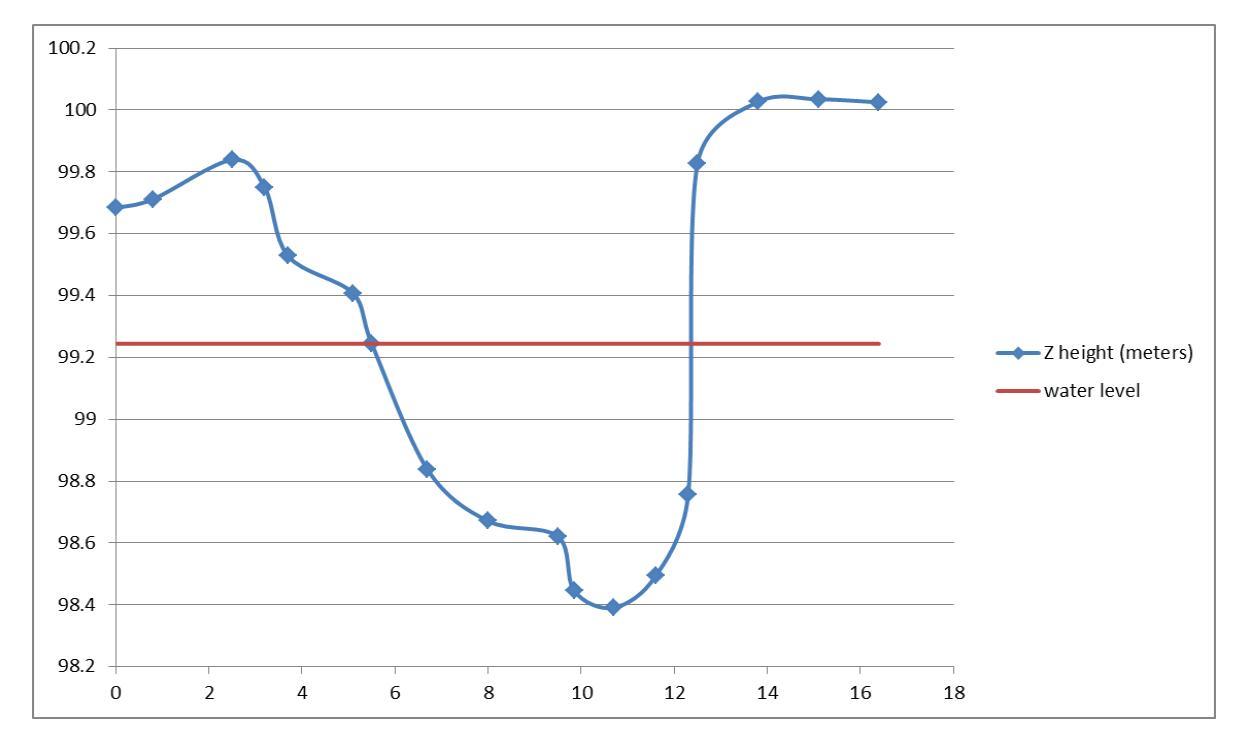
Figure 17 Cross section 8 elevation gradient

Cross section 8 was surveyed on the old channel upstream of sites 1, 2, 3, and 4 in the new channel. The location of the cross section was 41.7957 North and 72.2099 West. The geomorphology of channel can be characterized as an inactive, with an undercut bank. The geomorphic survey was conducted at a distance of 16.4m from the island flood plain to flood plain, traverse of the channel (**Fig 17**). The substrate of the stream varied in sediments and organic matter. On the near side of the channel there was terracing up to the water level 5.5m in. In the middle of the stream was an accumulation of leaves on the substrate. On the far side of the channel, the substrate becomes sandy. Before the far floodplain there is an overhanging of

the bank. The highest elevation on the near flood plain is 99.839m and highest at 100.035m on the far flood plain. The deepest point in the stream was 98.391m.

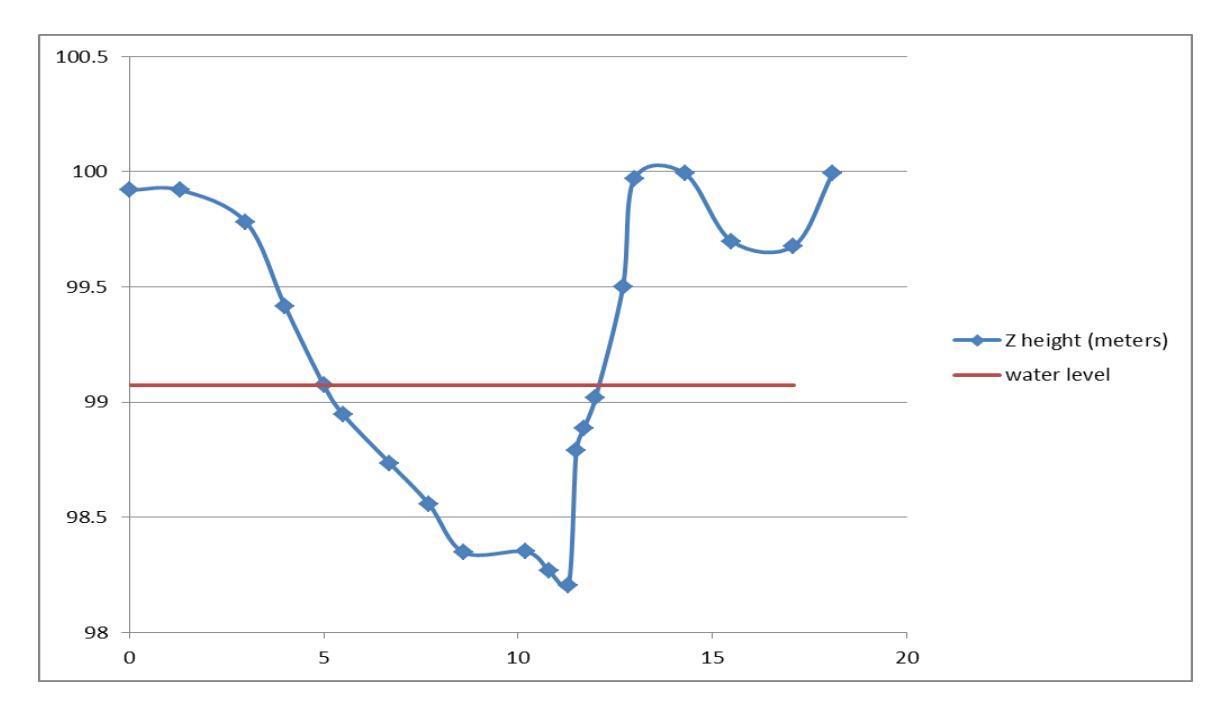
Figure 19 Cross section of site 9

Cross section 9 was surveyed upstream of site 8 in the old channel, and above sites 1, 2, 3, and 4 in the new channel. The location of the cross section was 41.79592 North and 72.2017 West. The geomorphic survey was conducted at a distance of 18.1m from the island flood plain to the flood plain traversing the channel (**Fig 19**). The substrate of channel was mixed from one end to the other. In the near channel after the flood plain there was terracing, and the water level began 5m in. For a few meters the substrate consisted of leaves. In the middle of channel the substrate becomes sandy with some gravel. On the far side of the channel the sand becomes mixed with compacted silty clay. Before the flood plain begins there is a small clay overhang. On the far flood plain there is small overland drainage channel in cleared gas line path. The highest elevation on the near flood plain was 99.92m and highest at 99.992m on the farthest flood plain. The deepest point in the channel was 98.204m.

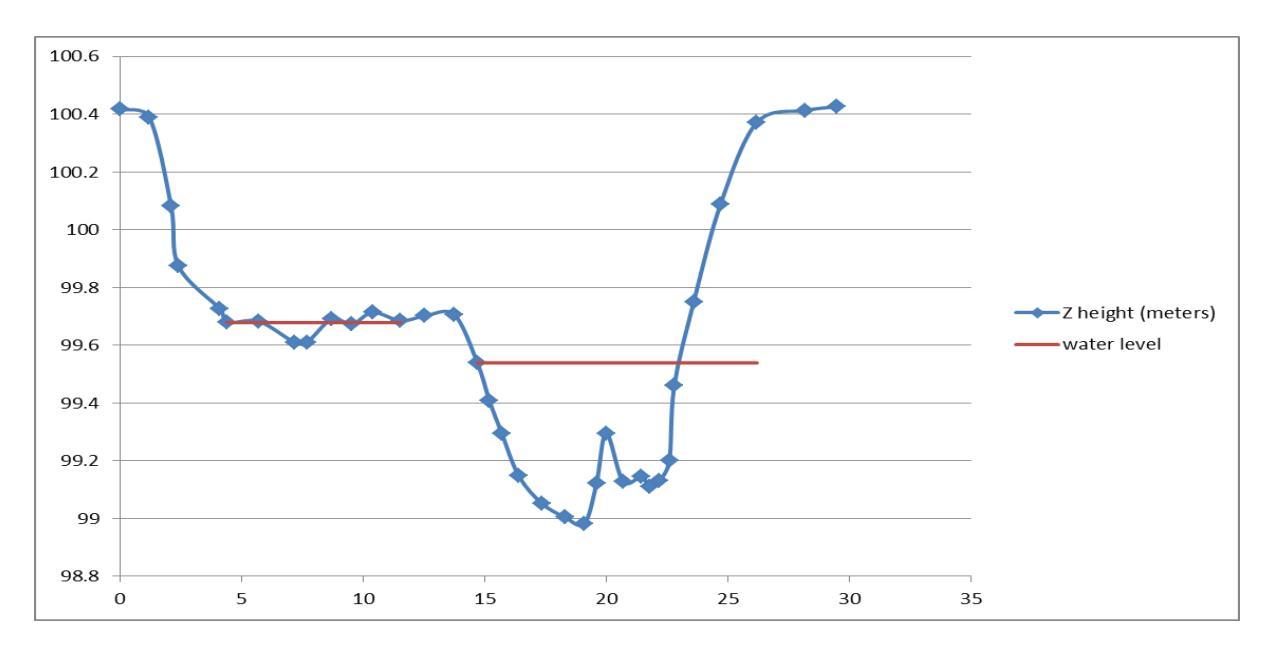
Figure 21 Cross section of site 10

Cross section 10 was surveyed upstream of sites 8 and 9 in the old channel above all sites in the new channel except for site 5. The location of the site was 41.79589 North and 72.2012 West. The geomorphology of the cross section could be characterized as a stream cutting across a flood bar and splitting the main channel creating a "C bend". The geomorphic survey was conducted at a distance of 29.5m from the flood plains of the channel (**Fig 21**). The substrate varied along the channel. On the near side of the channel after the bankfull, the bottom bank substrate was soil and gravel. After a high water level 4.4m in, a gravel flood bar is present in the stream. At 12.55m in there is a remnant of fallen tree. In the middle stream the substrate becomes gravel and then sand. After an accumulation of leaves, there is a sub-channel that forms on the far side of the channel. The substrate on this end is mostly sand and some gravel. Before the flood plain the substrate is sandy and silty soil. The highest elevation between flood plains are 100.417m for the nearest and 100.426m for the farthest. The deepest point in the stream was 98.982m.

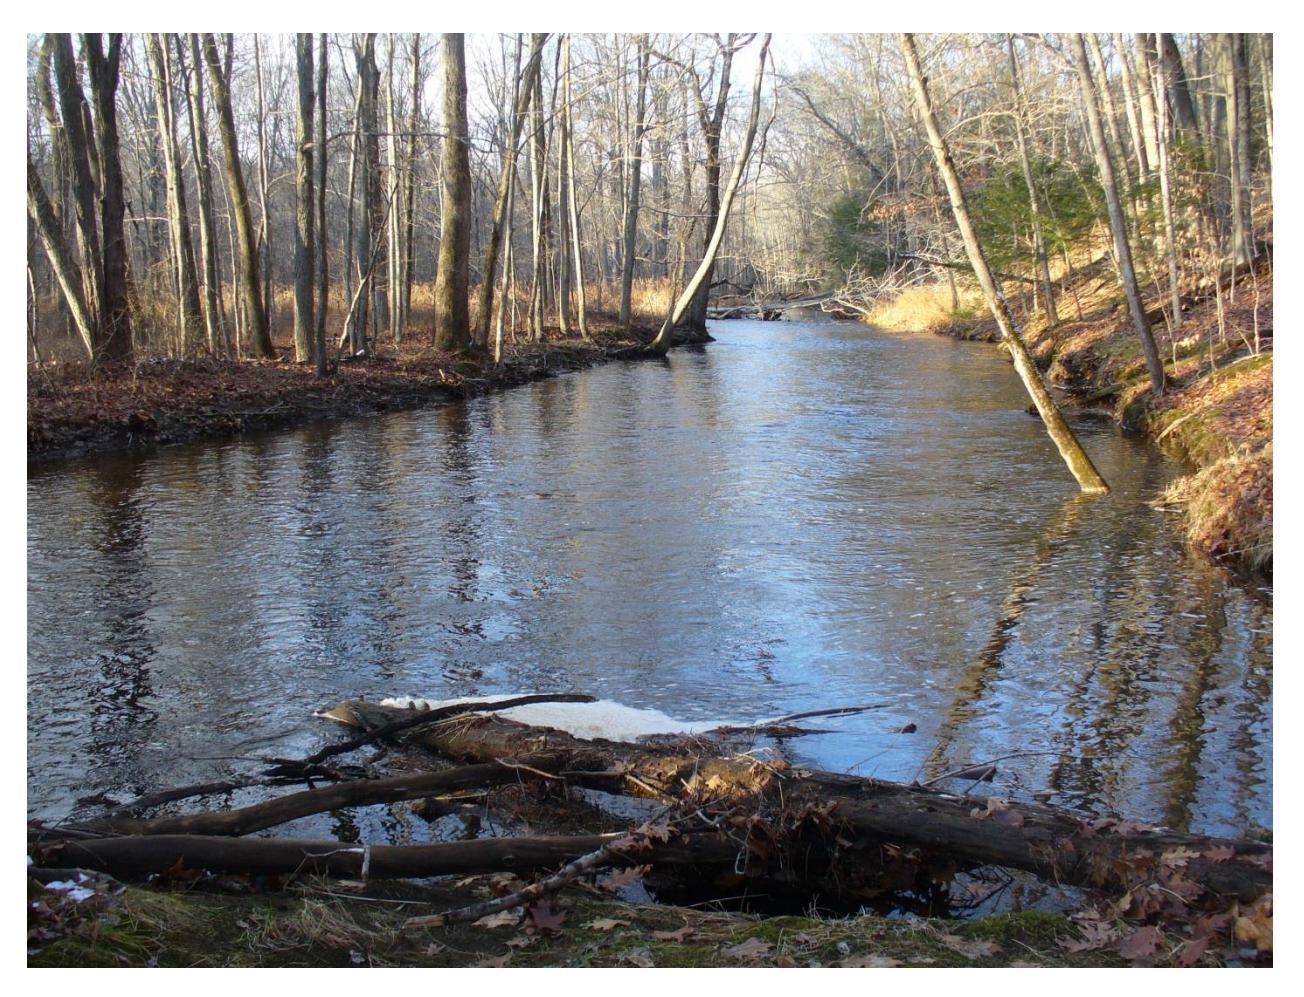
Looking upstream at channel upstream of surveyed reach, photo taken from east bank of westward curve of the channel

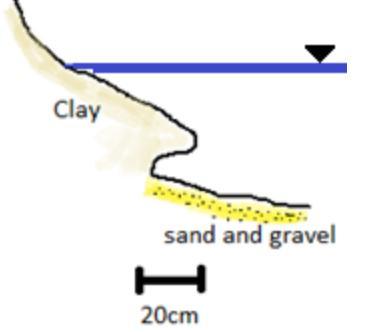
Looking toward the West bank in the relic channel. Note slumping trees from inactive cut banks and exposed banks. Above the exposed clays is looking down the tree cleared path of the gas line. The visible silt/clay is hard packed and continues underwater where there is a small undercut as described by the schematic.
